# Valhalla Wilderness Society

July 3, 2013

Ms. Robyn Roome, Regional Director  
Environmental Protection  
Ministry of Environment  
Nelson BC

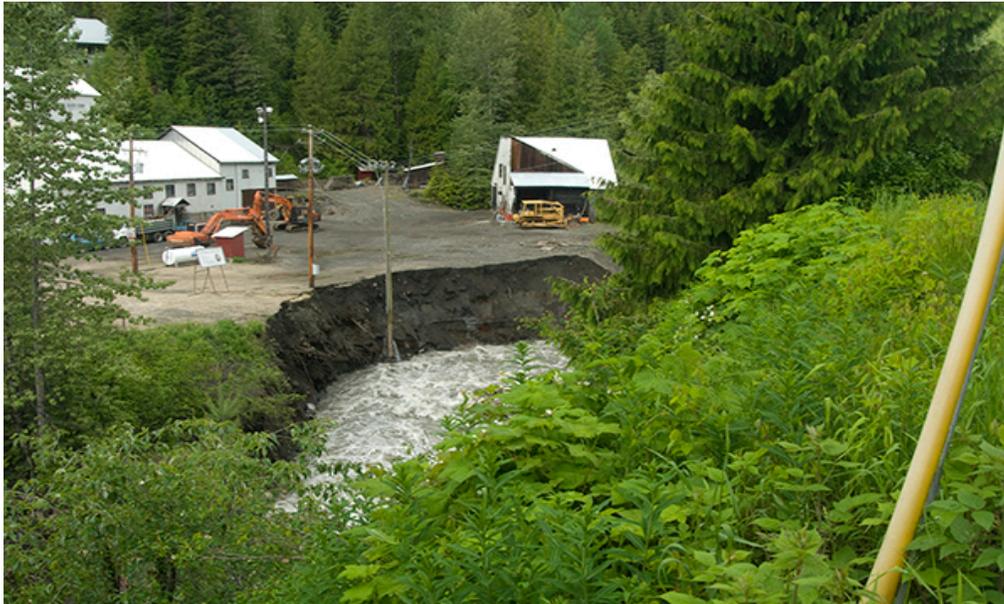
Valhalla Wilderness Society would like to bring to your attention a hazardous situation in Sandon that is getting worse yearly as government, industry and private landowners continue to ignore the threat of increasingly more devastating floods along Carpenter Creek. As you are probably aware during the spring flood of 2011 Carpenter Creek ate into Klondike Silver's maintenance yard at their office and concentrator site. This is shown in picture #2203 below.

As you can see this facility encroaches well into the flood plain and forms part of the creek bank. You can also see that there is a noticeable lack of armoring to protect against an even small flood event. We estimated that upwards of a 1/8th of the landing and marshalling area was washed away.

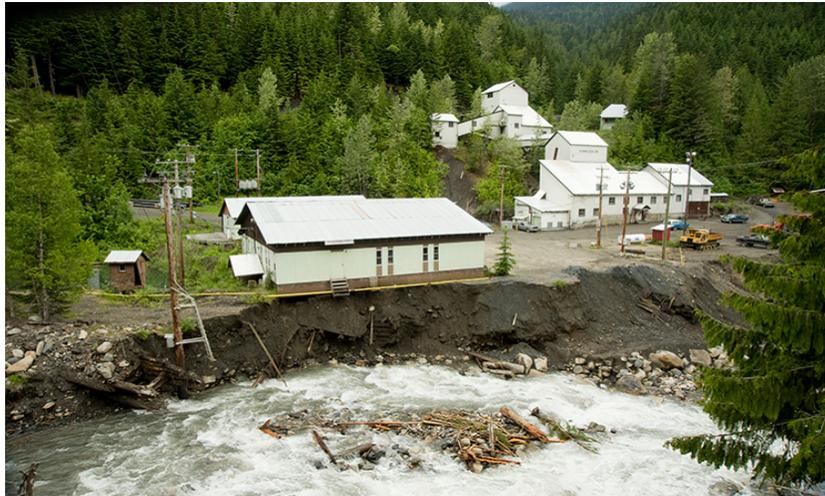
Now in 2013 Carpenter Creek has for each of the past three years had 1 in 75/100 year flood events. The creek has continued to eat into the concentrator maintenance yard to the extent that the office is undermined and poses a hazard to Carpenter Creek. This is shown in the following photograph:

Also seen is a paucity of armoring constructed since 2011. This mill yard has been in operation for close to 100 years if not more. All kinds of heavy equipment in various states of repair have been and are currently parked on this landing. Most likely there have been unreported fuel spills, fluid leaks from mine equipment and spills of chemicals from the concentrator such as cyanide used in the lead-zinc flotation tanks. All of this has been happening within the floodplain of the creek and much of it right on the creek bank. Some of these substances are carcinogenic and all of them are poisonous and they are all being washed downstream as the creek erodes this landing to Slocan Lake where they enter the lake within 20 meters of a public beach to the north and 100m to the south of the mouth of Carpenter Creek.

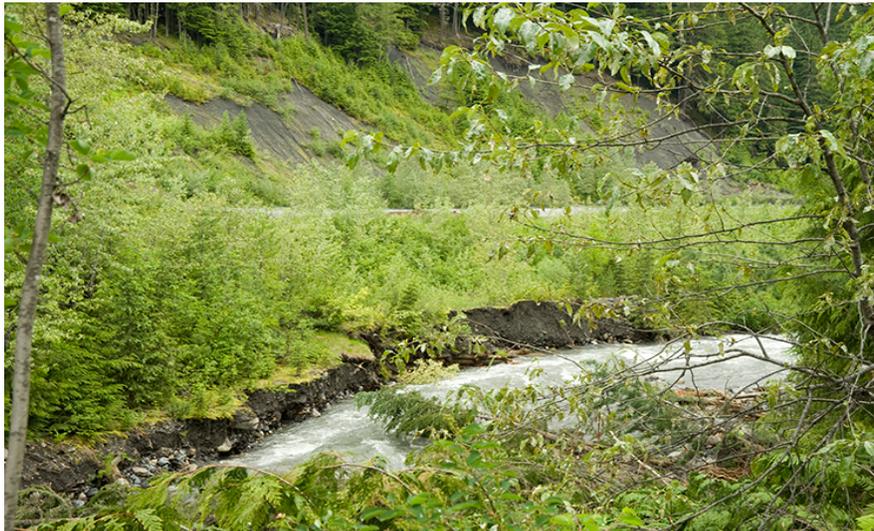
Not only that, but now Carpenter Creek is starting to cut into the base of several active tailings ponds, one shown in photograph #9435.

Valhalla Wilderness Society has been on written record since the mid 1990's, identifying the hazard posed by government agencies allowing these non armoured tailings ponds to be built into the flood plain of Carpenter creek, a creek notorious for extreme and destructive flood events. An old wing dam cribbing can be seen in this picture. A close up picture #9437 shows the dilapidated condition of the wing dam. These cribbings were built by the CPR to protect it's rail bed and are a minimum of 60 years old and many could date back to the late 1890's when the rail line was first built.

Regardless of when exactly they were built they are definitely old enough that their integrity can no longer be relied on to armor embankments. Should these tailings ponds be breached there are thousands of cubic meters of crushed fines, probably containing hazardous chemicals and heavy metals that would be washed down to Slovan Lake. When are government agencies going to demand and insist that these tailings ponds be adequately armoured to protect residents and resources located downstream?

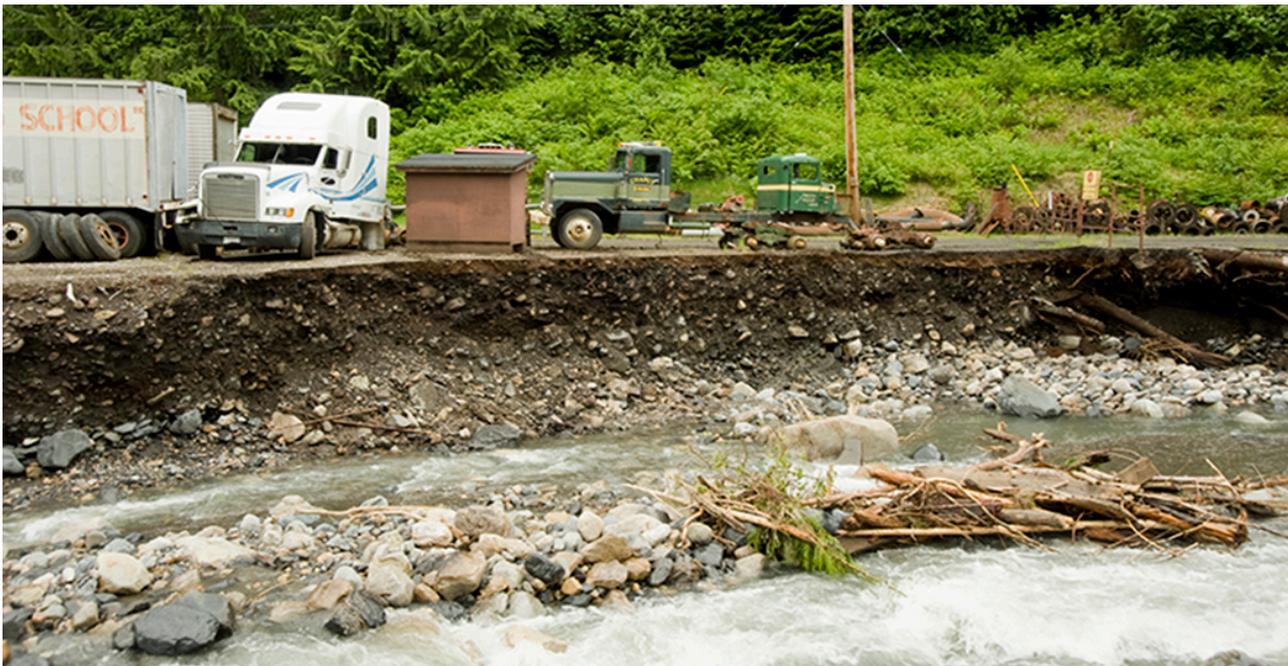
#9427

Another problem that is growing worse yearly is the parking and storing of heavy duty immobile equipment right up to the stream bank on allegedly private land. This year Carpenter creek eroded its banks to the point that this equipment was in danger of falling into the creek. Equipment parked on the stream banks is shown in the following photographs:

These pictures show some of the equipment parked in the flood plain and along the stream banks of Carpenter Creek. Much of this equipment contains fuel and well used lubricants that are known to be carcinogenic. Also can be seen are many old axles and wheel hubs, some of them installed on trucks, flatbed trailers and old busses. All these hubs are of an age that the brake linings are composed of asbestos and these hubs would contain quantities of asbestos dust generated as these linings have worn down. Asbestos even in small quantities is known to be carcinogenic. This is all perched on the stream bank and some equipment came a hairs breath from being washed downstream this year. The amount of immobile equipment is such that it cannot all be moved during an active flood event and it is only a matter of time that some of it will end up in the creek.
